Navajo Abandoned Uranium Mine

Site Screen Report

Syracuse Mine AUM Site

March 2010

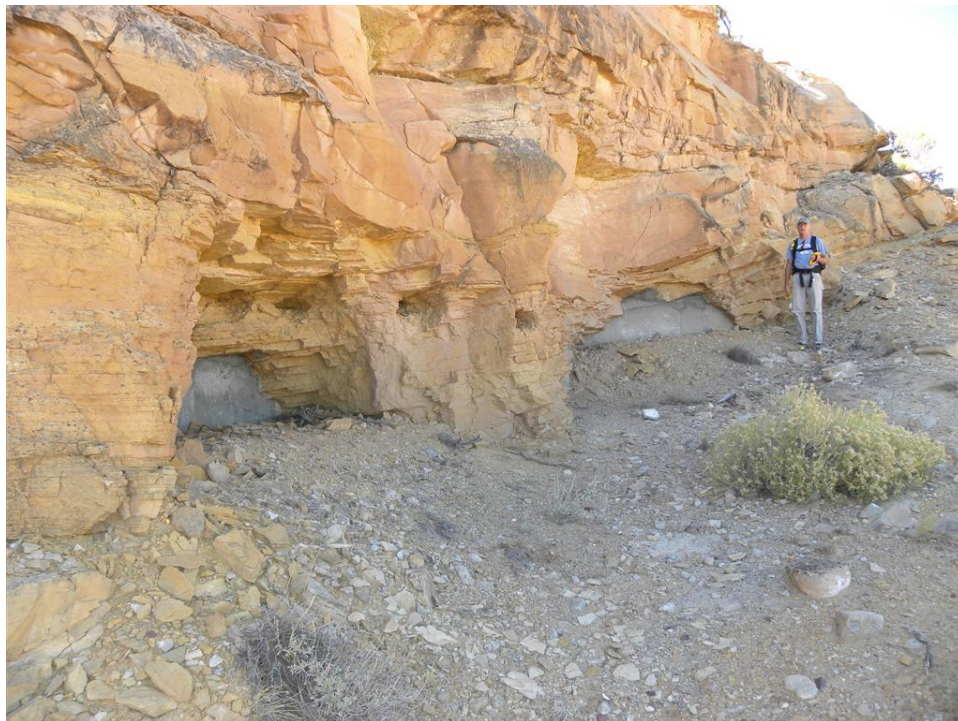
Photo 1. Sealed adits

3 concrete sealed adits

3 sealed adits; unreclaimed waste pile

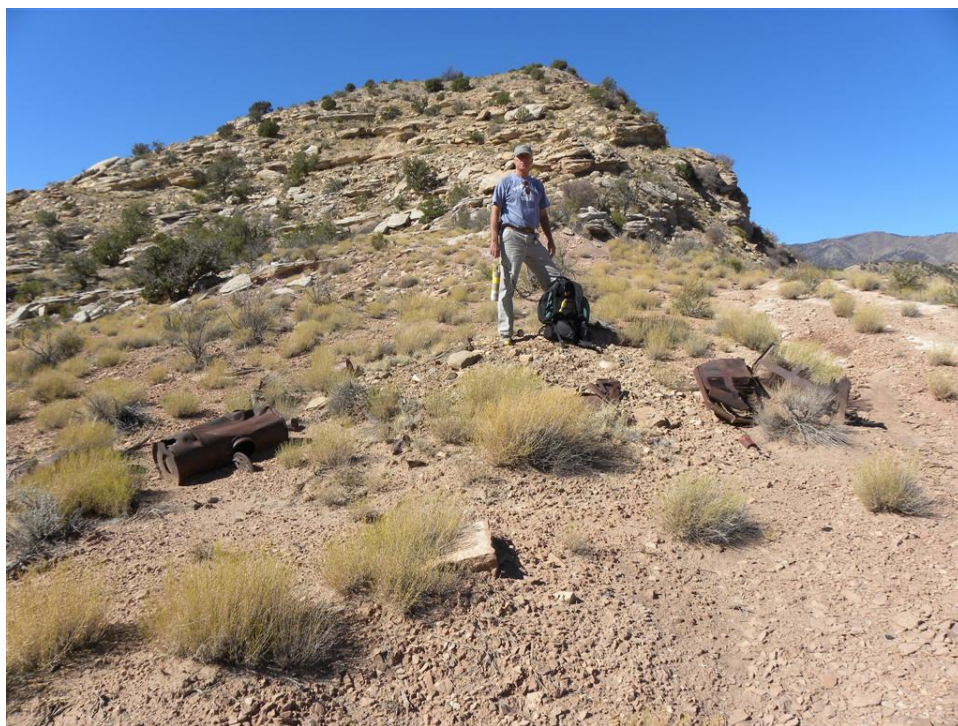
Photo 4. Mine site with waste debris

Waste pile with mechanical debris east of mine, 100' x 50', with a total estimated volume of 926 yd³
